OF THE NATIONAL ACADEMY OF SCIENCES OF THE REPUBLIC OF KAZAKHSTAN

Volume 1, Number 433 (2019), 195 – 205

**DEVELOPMENT OF ABRASION SHORES OF ALAKOL LAKE
ACCORDING TO THE FIELD RESEARCH MATERIALS**

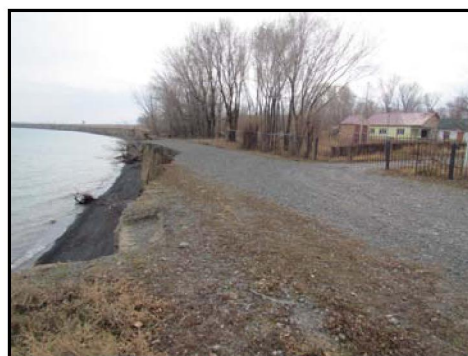
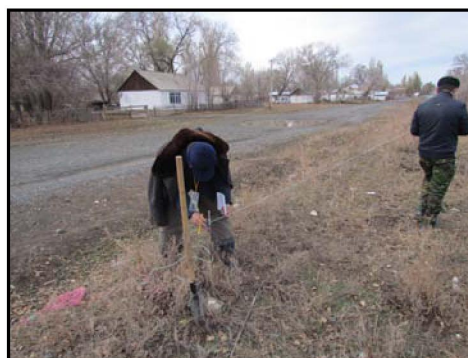
Figure 2 – Data of the monitoring site № 4, Koktuma village, Almaty region

The monitoring site № 4 (figure 2) was founded in 2013. Two main benchmarks were installed at it, and geographic coordinates from two concrete supports were taken as additional benchmarks. According to the 1st and 2nd benchmarks, the dynamics of the retreat of the edge of the cliff toward the land is 9.4 m for three and a half years. At the 7th benchmark, located in the southern part of the monitoring site, the three-year values amounted to 9.9 meters. Residential buildings and infrastructure facilities are located in 50-60 meters from the coastal cliff. Local residents state the fact of the annual approaching of the coastal cliff to their houses. The asphalt road is cut off by the cliff in the south direction. The analysis of the obtained results showed an increase in the rate of shoreline erosion at the reference site from north to south.

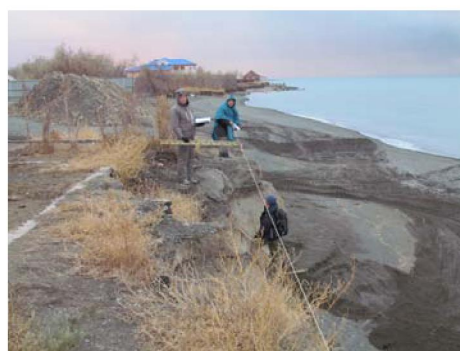
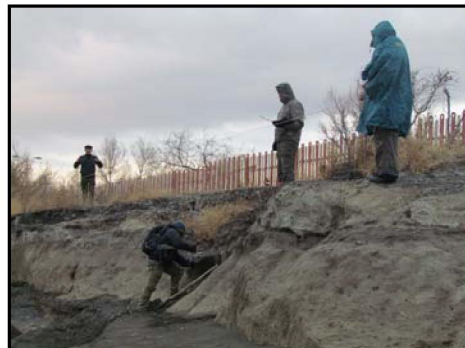
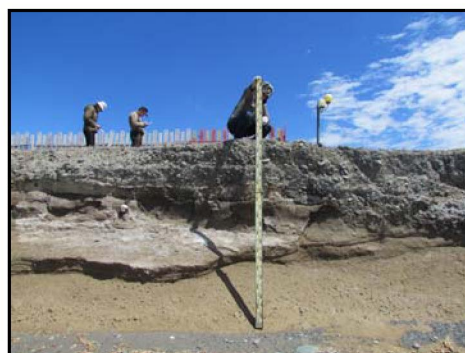
Figure 6 – Scheme of monitoring site № 2, recreational center of the Kabanbai village, East Kazakhstan region

Three benchmarks were installed along the profile on the monitoring site № 2 in 2013 (figure 6). Distances from the edge of the cliff to the benchmarks were from 3.5 to 7 meters. There is a metal fence of the private rest house parallel to the cliff at the indicated distances. Only two benchmarks along the lines of the profiles № 2 and 3 were kept when carrying out instrumental measurements in 2016. The first benchmark was destroyed by abrasion. In May 2013, the distance from the benchmark to the edge of the cliff was 3.68 m. Dynamics of development of shoreline erosion at the reference site № 4 was determined for each benchmark with a perpendicular direction to the cliff. At the 1st benchmark, it is presumably 4 m for three and half years, at the 2nd benchmark – 4.24 m, at the 3rd benchmark – 3.7 m.

New benchmarks were installed to fix the dynamics of the abrasion process for further field monitoring of the abrasion process. Three street lamps located on the territory of the summer recreation center were selected as benchmarks. They are located at a considerable distance from the edge of the cliff and are oriented along the shoreline. The coordination of new benchmarks, fixing the distances to the edge of the cliff in the west direction relative to all three lamps, was carried out.
