Volume 5, Number 443 (2020), 81 – 88

INFLUENCE OF SYSTEM ERRORS IN METEOROLOGICAL SUPPORT ON FLIGHTS SAFETY

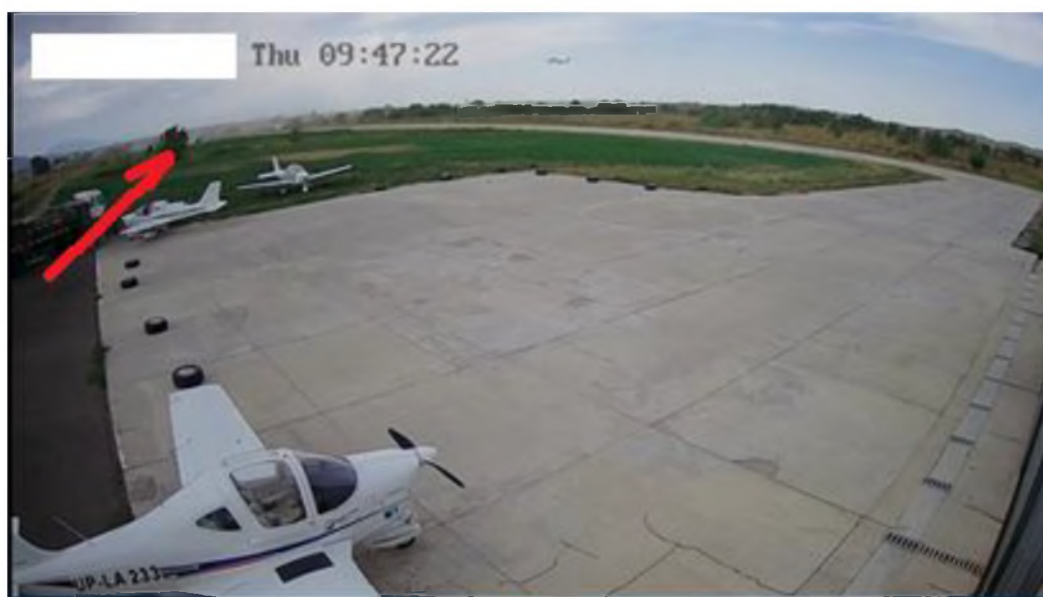
Figure 1 – Weather conditions in the area of the aerodrome during take-off

Judging by the recording from the video in the aerodrome area, about 8 cumulonimbus cloud points were observed in accordance with figure 1, 2. In the upper left corner of the recording, clouds with a dark lower edge is recorded. When analyzing the weather using video materials, the height of the ceiling was determined using the Google Earth Pro program and photo materials from the scene. It was established that the height of the ceiling in the area of the aerodrome was supposedly about 600 m.

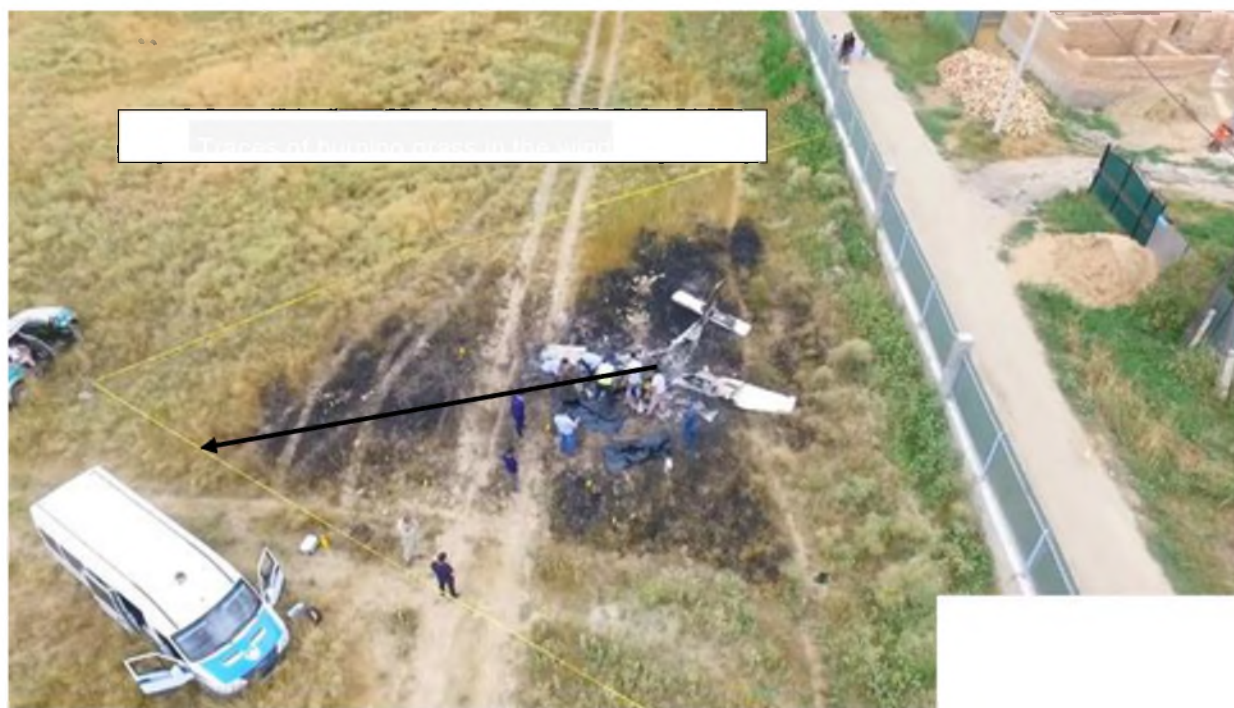
Figure 3 – Calculation of the direction of the wind from the traces of burning vegetation at the place of aircraft crash landing

The direction of the wind, in accordance with the spread of burning traces, at the crash area was 200-230 ° in accordance with figure 3.

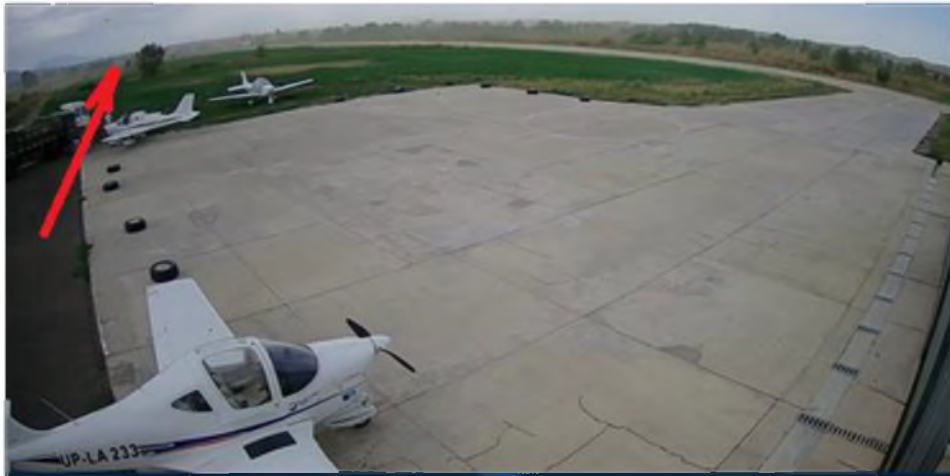
Figure 4 – Deterioration of visibility, increased wind and dust disruptions at the aerodrome

The wind speed at the airport during the incident was determined by recording surveillance cameras using the Beaufort scale. At 9.46 local time, the wind force was 5.3 - 7.4 m / s, after a second it reached a force of 12.5 - 19.2 m / s.

Recording a video camera at this time captures the swaying of trees near the ground, a little later the swaying of aircraft in the parking lot and dust breakdowns, which confirms the presence of a flurry, which is shown in figures 4, 5 and 6.

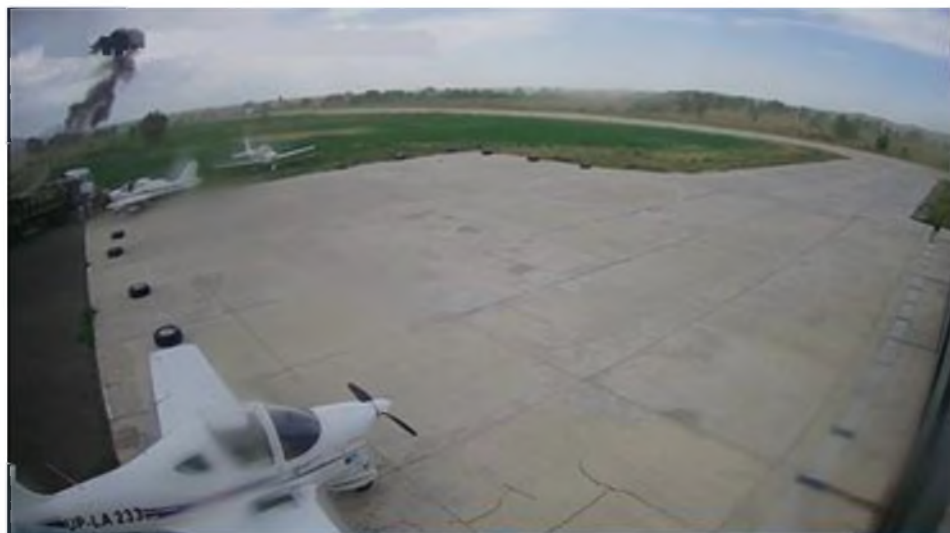
Figure 6 – Smoke propagation and vibration of aircraft parked due to the effects of wind after an accident at an aerodrome

The crew tried to correct the situation, but the descending air currents did not allow this and the aircraft crashed. The direction of the air flow confirms the direction of the smoke from the explosion of the aircraft, which is shown in photo 6.

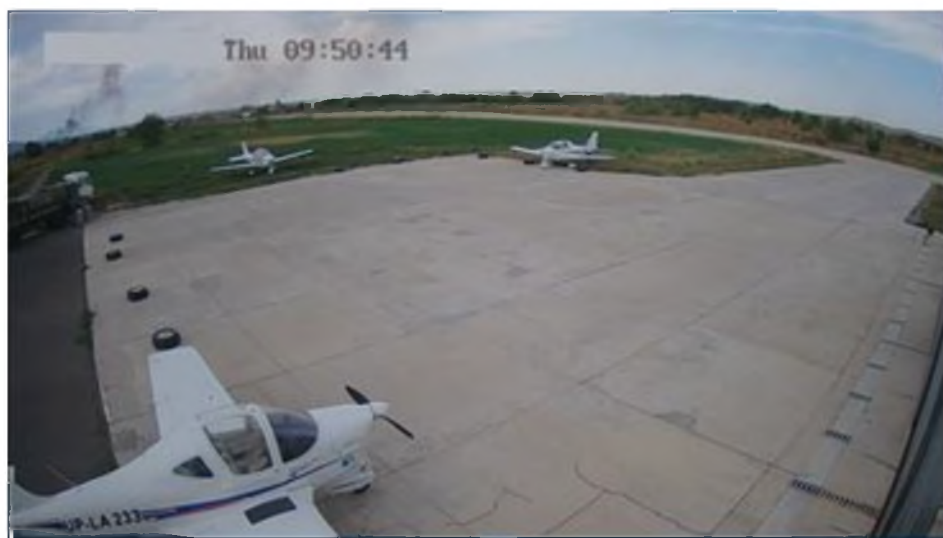
Figure 7 – Weather conditions at the aerodrome after an accident

A flurry was limited in space and lasted for 2-3 minutes, and was recorded on the camcorder for about two minutes.
